Inspection Report

Absolute Assurance Home Inspection Services, LLC

123 Elm Street, Anywhere, MD 22222

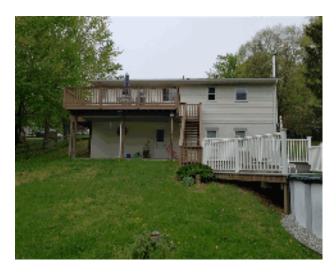
1) Grading Conditions

Grading of the soil near the foundation appears to be in serviceable condition.

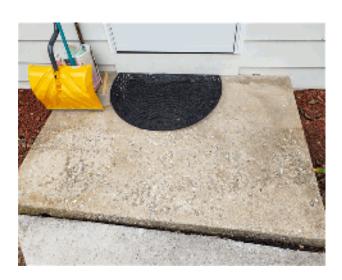
The visible portions of the stoop appeared to be in serviceable condition at the time of the inspection.

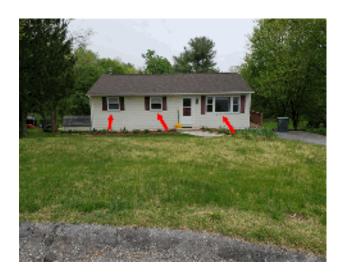
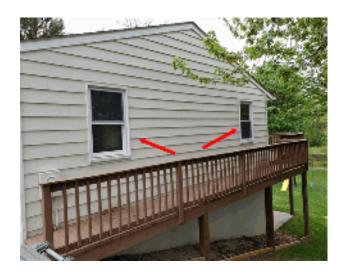
Exterior windows appeared to be in serviceable condition at the time of this inspection.
